# Manhole Inspection Summary

Manhole # S15KK1021MH

Insp Date: **6/19/07 9:01 AM**

**Location** Address: **2530 EDGECOMBE CIR N**

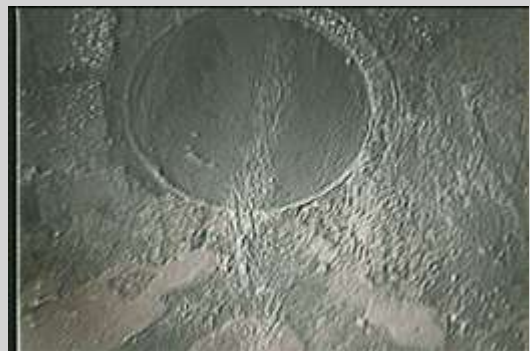
### Drop In @ 3 O'Clock

Drop: **Outside** Rod and Bar

Angled: **Yes** Reading: **10.24** (ft.)

Inv Depth: **11.24** (ft.)

Drop Condition: **Open**

Connects To: **Manhole**

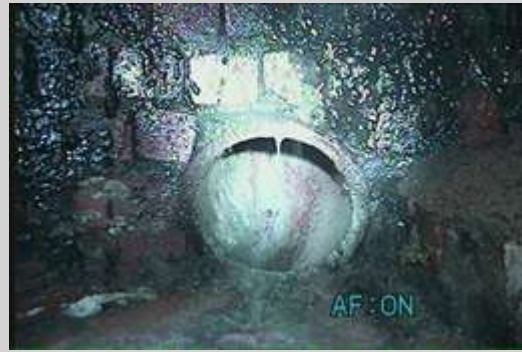
Drop In @ 6 O'Clock

Drop: **None**

Connects To: **House connection / Service line**
